Aquatic Facility Evaluation City of Merriam, Kansas

Kyle A. McCawley, P.E.

Larkin Aquatics

4/9/2014

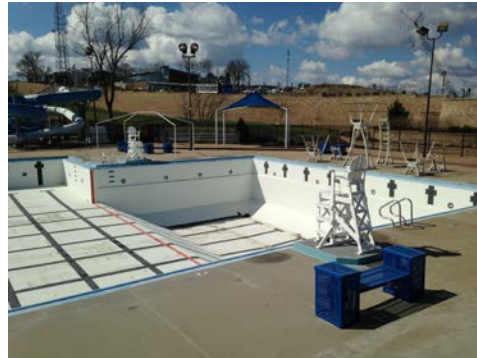
Fig 1. Main Pool Basin

Minimal cracking and delamination of concrete was observed in the pool basin. This is expected given the facility's age. The observed cracks pre-date the most recent coat of paint and there is no visible indication of recent movement within the cracks. However, the cracks should not be disregarded. Any crack is a potential source of leakage. The appropriate course of action is to carefully monitor the existing cracks for further movement. The cracking and delaminating concrete should be repaired or replaced immediately.

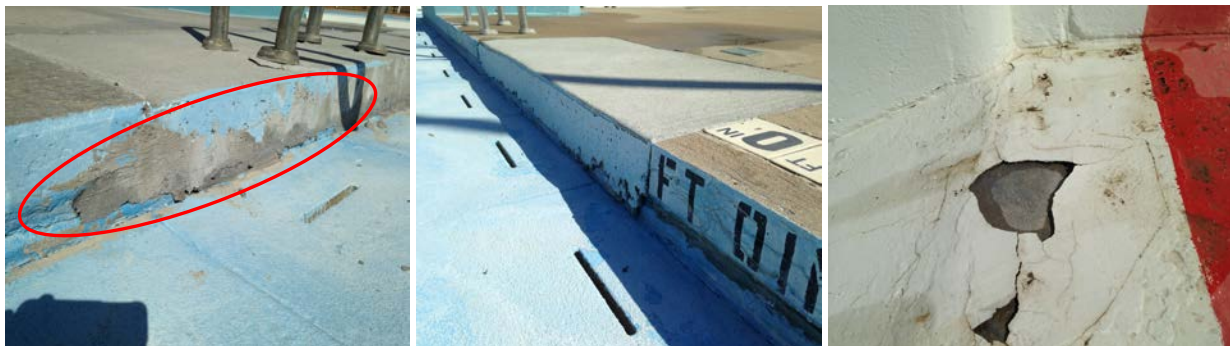
The pool basin has a joint between the top of the gutter and the pool deck. It was observed that this joint had some deterioration in various locations around the pool. This damage appears to have been repaired by City Staff. The repair seems to be in satisfactory

condition. However, it should be monitored for further deterioration. Also, because of the age of the facility, it is very likely that this joint will continue to be problematic. The City should consider a long-term solution.

During the examination of the basin, concrete delamination was observed at the deep-end joint transition. At this location thin layers of concrete were separating from the basin. This separation shall be repaired in order to prevent water penetrating the concrete basin and causing further damage. It should also be repaired in order to prevent a safety issue for patrons.

Fig 2. Deteriorated gutter/deck joints and delaminating concrete

1. Monitor any cracks in the gutter/deck joint. Repair as needed, approximately every 2-4 years.
2. Create a long term solution for the gutter/deck joint.
3. Repair the delaminating concrete at the deep-end transition.
4. Replace missing pool lights.

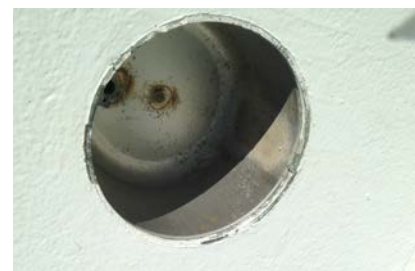
During the inspection of the facility five pool lights were missing from the in-pool light system. The lights should be replaced in the near future.

Fig 3. Missing pool light

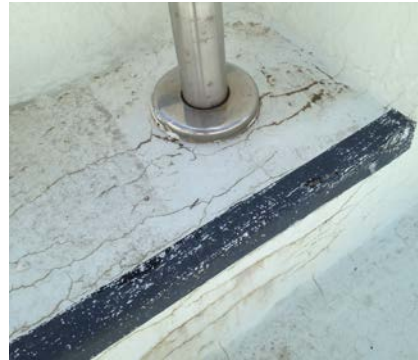
Fig 4. Capped Skimmer Line

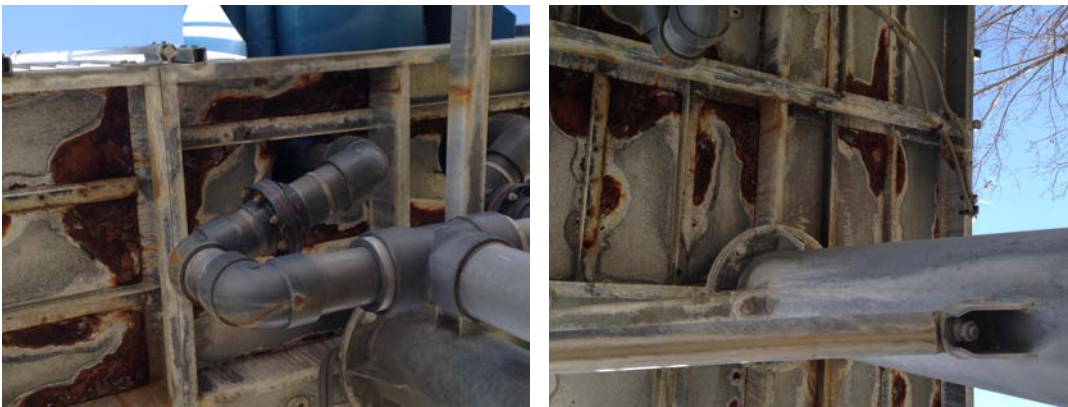
During the inspection of the slide pool the slides and slide tower were evaluated. It was observed that the amenity needs attention in the near future. The underside of the slide tower exhibits excessive corrosion. There is corrosion on the structural steel and the tower decking. The corrosion on the structural steel is noticeable, however it seems to be minimal staining from the decking deterioration. The vast majority of the corrosion is from the tower decking. While this is unsightly, the main concern is the long term structural integrity of the system. It is recommended that the entire decking be replaced. And it is recommended that the structural steel be cleaned and recoated by a manufacturer's certified representative.

Fig 5. Corrode slide tower

1. Repair slide steps
2. Replace the slide tower decking
3. Clean and recoat the structural steel
4. Reseal slide seams

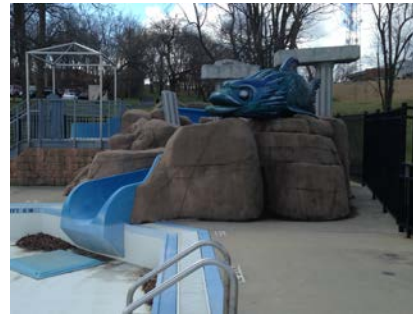
Fig 6. “Old Man and the Sea” Feature

The wading pool does require attention. The slide pump located in the “Old Man and the Sea” structure overheats while in operation. The structure should be modified to include ventilation within the space.

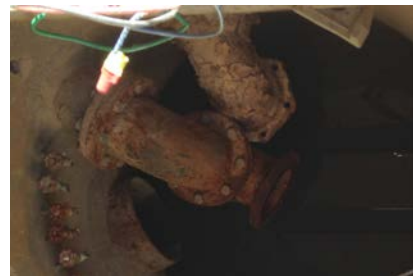
It was also observed that the pool drain piping is corroded. It is recommended that the piping be replaced.

Fig 7. Corroded drain pipe

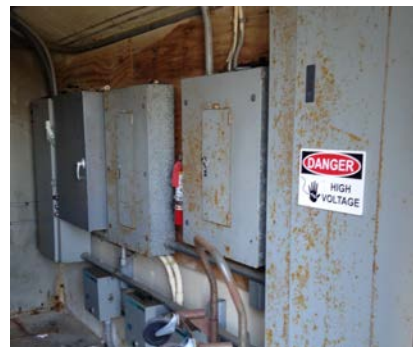
There are areas that still require attention in the mechanical room. There is corrosion on the electrical panels with in the mechanical space, however, at this point the corrosion appears to only be surficial. It should be cleaned to prevent detrimental deterioration.

Fig 8. Surface corrosion

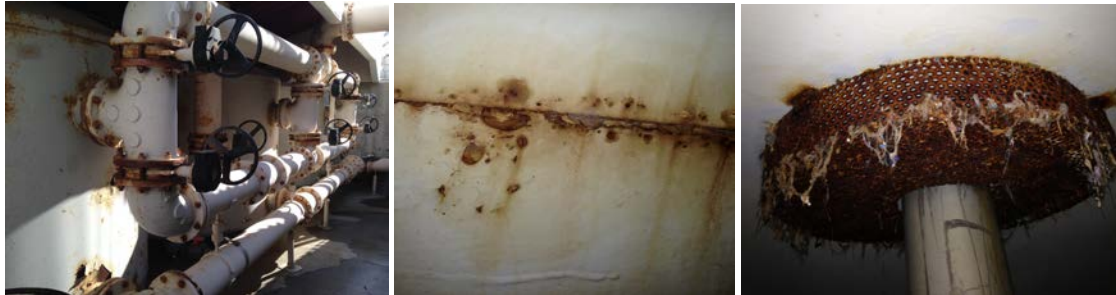
Fig 8. Filter system

The filtration system needs to be addressed in the near future. The existing filter tanks have corrosion in the piping, welded seams, internal baffle and the access hatch. This is an indication that the filter tanks are near the end of their useful life. It is recommended that they are replaced.

1. Clean surficial corrosion on the electrical panels
2. Replace the filtration system

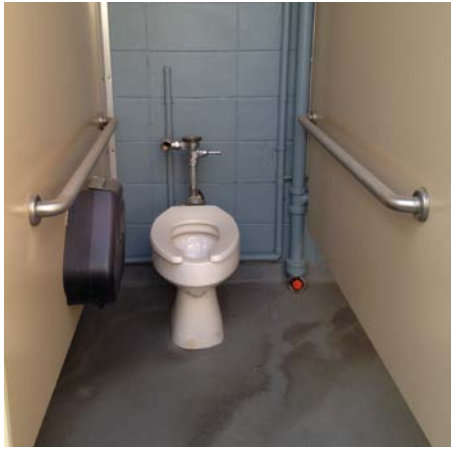
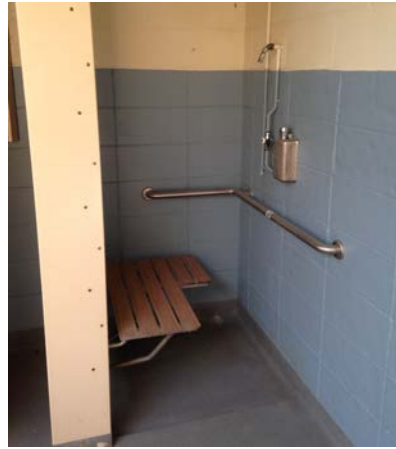
The interior of the bathhouse does not fully comply with the guidelines established by the Americans with Disabilities Act (ADA). The main issues are:

- Inadequately sized water closets
- Noncompliant lavatories

- Showers do not meet the dimensional requirements

Fig 12. Non-ADA compliant

Fig 13. Non-ADA compliant

1. Replace the skylights
2. The water closets should be renovated to have proper grab bars and proper clear-floor space per the ADA regulations.
3. The lavatories should be hung at the correct height and locations per the ADA regulations.
4. The showers should be renovated per the ADA.
