Aquatic Facility Evaluation City of Merriam, Kansas

Kyle A. McCawley, P.E.

Larkin Aquatics

4/9/2014

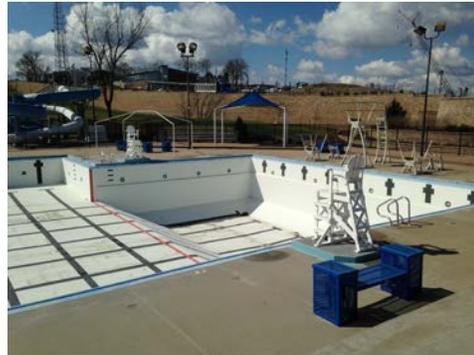
Fig 1. Main Pool Basin

Minimal cracking and delamination of concrete was observed in the pool basin. This is expected given the facility's age. The observed cracks pre-date the most recent coat of paint and there is no visible indication of recent movement within the cracks. However, the cracks should not be disregarded. Any crack is a potential source of leakage. The appropriate course of action is to carefully monitor the existing cracks for further movement. The cracking and delaminating concrete should be repaired or replaced immediately.

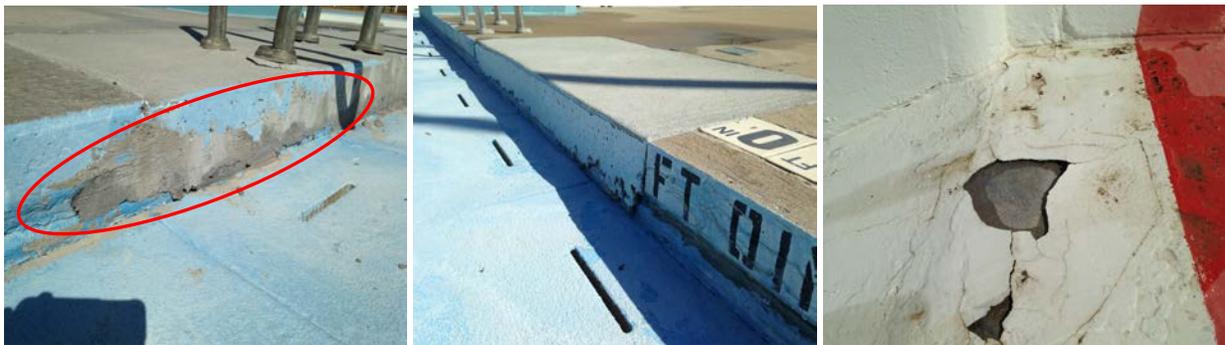
The pool basin has a joint between the top of the gutter and the pool deck. It was observed that this joint had some deterioration in various locations around the pool. This damage appears to have been repaired by City Staff. The repair seems to be in satisfactory

condition. However, it should be monitored for further deterioration. Also, because of the age of the facility, it is very likely that this joint will continue to be problematic. The City should consider a long-term solution.

During the examination of the basin, concrete delamination was observed at the deep-end joint transition. At this location thin layers of concrete were separating from the basin. This separation shall be repaired in order to prevent water penetrating the concrete basin and causing further damage. It should also be repaired in order to prevent a safety issue for patrons.

Fig 2. Deteriorated gutter/deck joints and delaminating concrete

1. Monitor any cracks in the gutter/deck joint. Repair as needed, approximately every 2-4 years.
2. Create a long term solution for the gutter/deck joint.
3. Repair the delaminating concrete at the deep-end transition.
4. Replace missing pool lights.

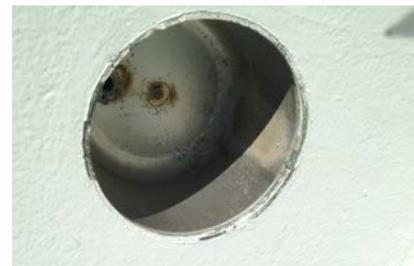
During the inspection of the facility five pool lights were missing from the in-pool light system. The lights should be replaced in the near future.

Fig 3. Missing pool light

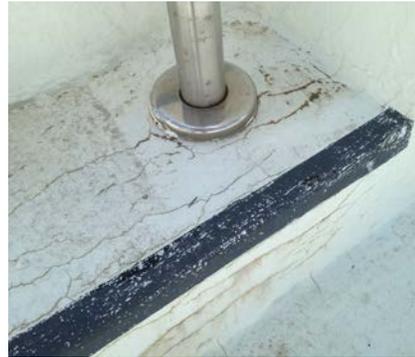
Fig 4. Capped Skimmer Line

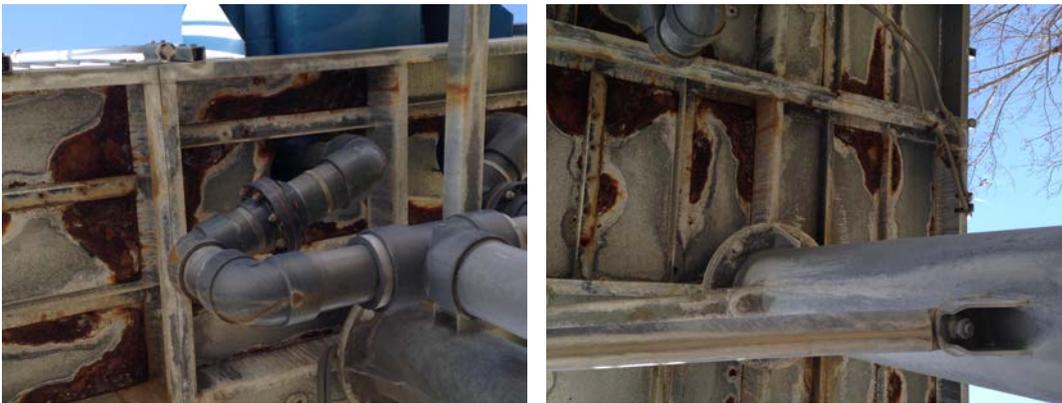
During the inspection of the slide pool the slides and slide tower were evaluated. It was observed that the amenity needs attention in the near future. The underside of the slide tower exhibits excessive corrosion. There is corrosion on the structural steel and the tower decking. The corrosion on the structural steel is noticeable, however it seems to be minimal staining from the decking deterioration. The vast majority of the corrosion is from the tower decking. While this is unsightly, the main concern is the long term structural integrity of the system. It is recommended that the entire decking be replaced. And it is recommended that the structural steel be cleaned and recoated by a manufacturer's certified representative.

Fig 5. Corrode slide tower

1. Repair slide steps
2. Replace the slide tower decking
3. Clean and recoat the structural steel
4. Reseal slide seams

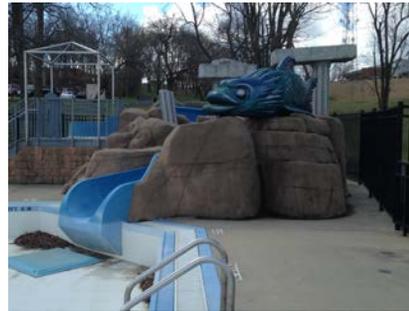
Fig 6. “Old Man and the Sea” Feature

The wading pool does require attention. The slide pump located in the “Old Man and the Sea” structure overheats while in operation. The structure should be modified to include ventilation within the space.

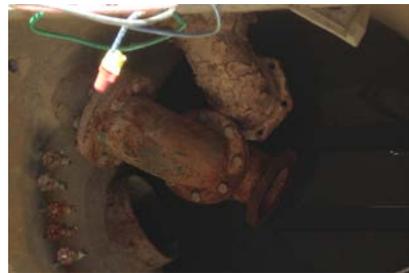
It was also observed that the pool drain piping is corroded. It is recommended that the piping be replaced.

Fig 7. Corroded drain pipe

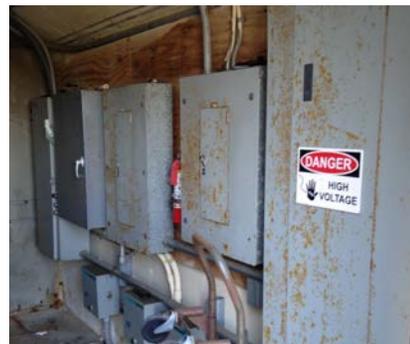
There are areas that still require attention in the mechanical room. There is corrosion on the electrical panels with in the mechanical space, however, at this point the corrosion appears to only be surficial. It should be cleaned to prevent detrimental deterioration.

Fig 8. Surface corrosion

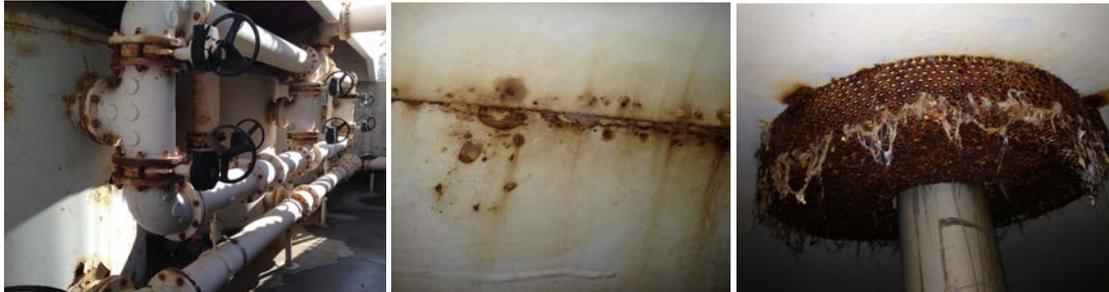
Fig 8. Filter system

The filtration system needs to be addressed in the near future. The existing filter tanks have corrosion in the piping, welded seams, internal baffle and the access hatch. This is an indication that the filter tanks are near the end of their useful life. It is recommended that they are replaced.

1. Clean surficial corrosion on the electrical panels
2. Replace the filtration system

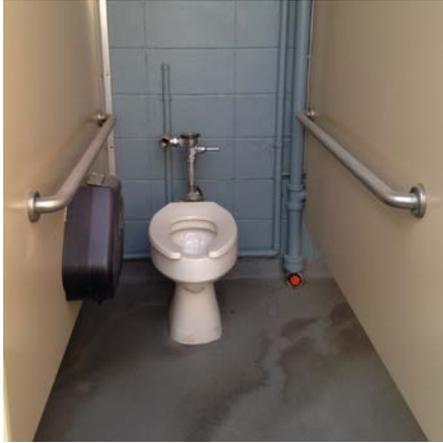
The interior of the bathhouse does not fully comply with the guidelines established by the Americans with Disabilities Act (ADA). The main issues are:

- Inadequately sized water closets
- Noncompliant lavatories

- Showers do not meet the dimensional requirements

Fig 12. Non-ADA compliant

1. Replace the skylights
2. The water closets should be renovated to have proper grab bars and proper clear-floor space per the ADA regulations.
3. The lavatories should be hung at the correct height and locations per the ADA regulations.
4. The showers should be renovated per the ADA.

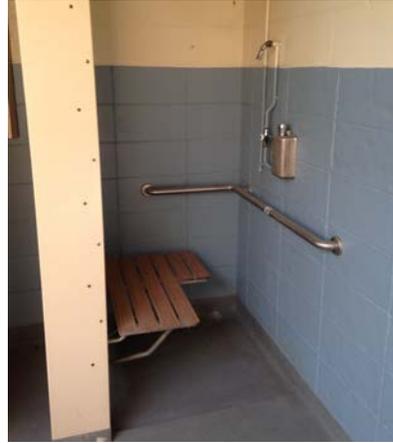
Fig 13. Non-ADA compliant
